Conservation Management Plan for the Blast Furnace Remains at Whitegate, Co. Clare

History, survey and structural assessment

November 2015

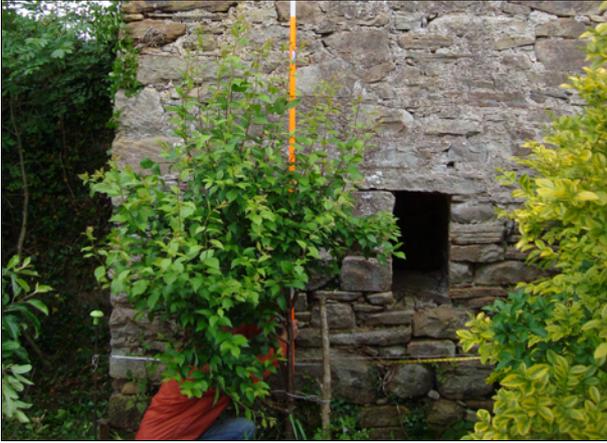
Fig. 6. Window in the west wall

The west wall is just over 7.8m long and 6.8m high (Fig. 4 and 5). It is a plain wall with the exception of a window on its lower northern side connecting to the passageway (Fig. 6). This window is 0.68m high and 0.32m on its exterior. The window is splayed towards the south and is 0.48m wide where it meets the passageway. This passageway exits in the chamfered south west wall (Fig. 7 and 8).

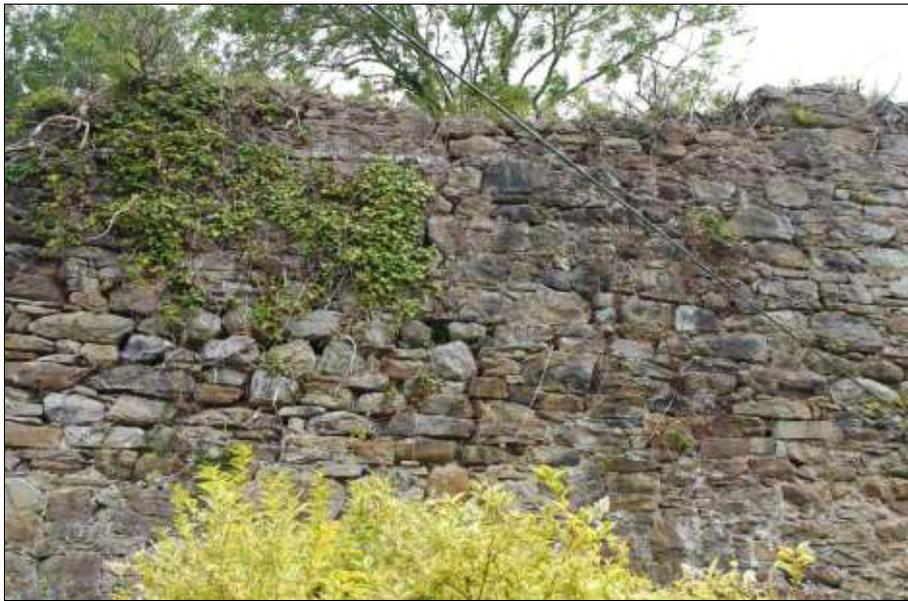
Fig. 19. Crack in the west wall

The West wall, on inspection, looks to be structurally sound however it does show signs of structural stresses and cracks (Figs. 19). There is a band of well pointed masonry approx. 1m from the ground and extending 2m above. The pointing of the stone below and over this area has been mostly washed out. The wall top is uneven and there is a lot of vegetation growing from it. There is some damage apparent to the opening of the passageway where stone has been robbed out from the open arch. A crack is visible in the centre of the West wall running from the top down approx. 4m.

- A crack monitor should be placed on the West wall crack to determine if there is any existing movement. Results should be monitored periodically and action taken if necessary.

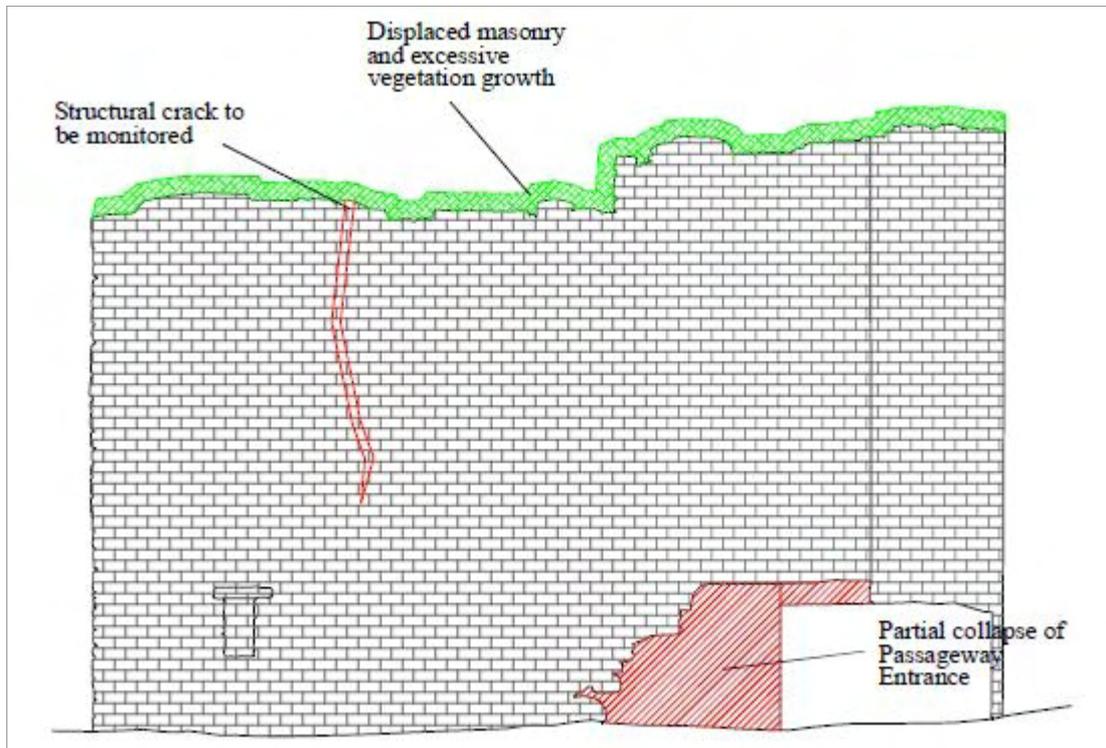
Fig. 20. Problem areas on the west wall

The West wall is structurally sound however works are required to prevent any further deterioration of the wall namely the wall top, passageway arch and the crack in the centre (Fig. 20). Much of the wall is also in need of re-pointing to prevent further washing out of the joints.

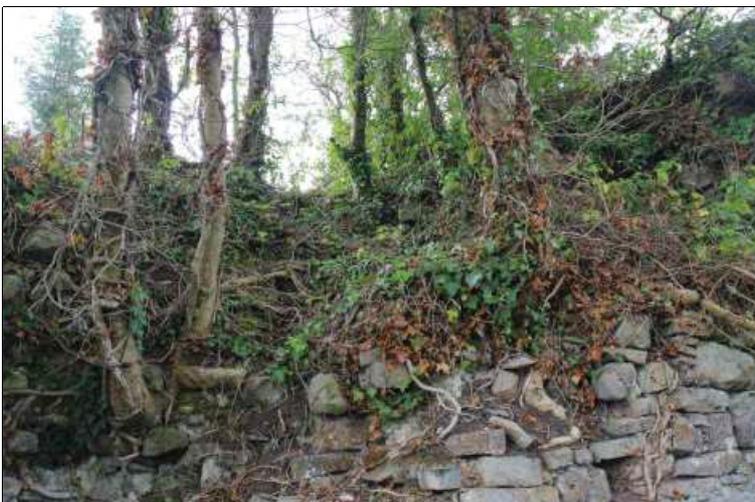
Fig. 21. Trees on the north wall

The North wall has suffered major structural failure in the past. This is probably due to the growth of tree roots displacing the stone above (Fig. 21). There is an opening to the passageway from the breach in the North wall. Quite a substantial amount of stone is being displaced by ivy growth and is in danger of falling at the north east corner (fig. 22). At the north west corner the rear of the West wall can be seen to be very overgrown with ivy and vegetation. The height of the North wall has been greatly reduced compared to the West.

- Removal and treatment of the trees growing on the furnace top. Further investigations are necessary prior to removal of any tree to be certain it is not providing any structural support to the stone structure.

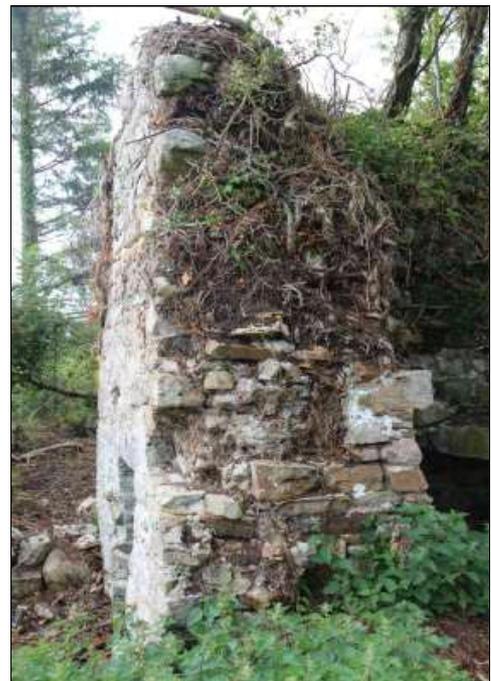
Fig. 22. North east corner

The North elevation is very overgrown and has seen much structural collapse (Fig. 23 and 24). The north east corner stones are being dislodged by vegetation and are in risk of falling. The removal of vegetation from the rear of the West wall top is necessary also to assess any existing structural issues. The trees growing on the furnace top and off the North elevation need to be further assessed to investigate the amount of structural damage being done and the best treatment for each one. The breach into the passage way should be made good to prevent any further collapse.

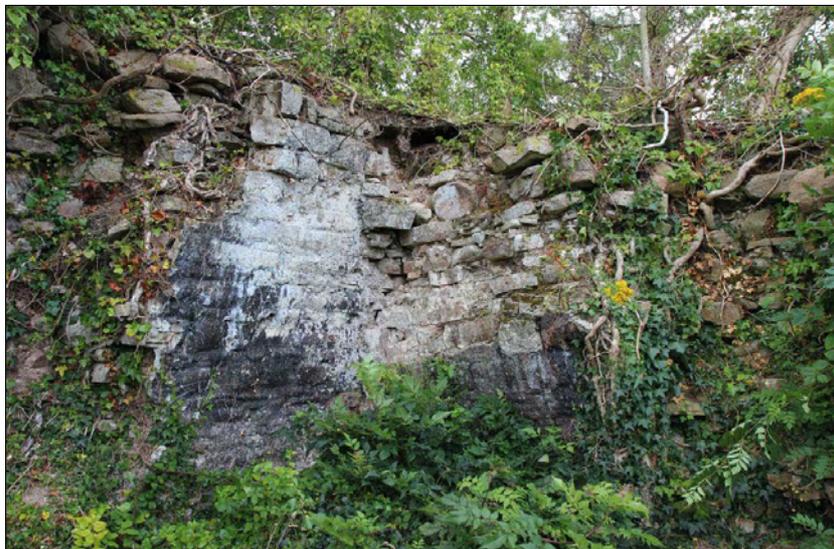
Fig. 25. Exposed inner lining of the furnace

The south east elevation features the exposed inner lining of the furnace chimney (Fig. 25) and the remains of the two arches used to work the furnace. The base of the south east corner (where both

arches would have met) is still in place but both arches have been completely removed. Part of the original lime render lining is still present. The stone in the centre of the structure is burnt and brittle. Much of the interior of the furnace has been robbed out/collapsed and there is a lot overhanging stones and vegetation. No major structural cracks are evident.

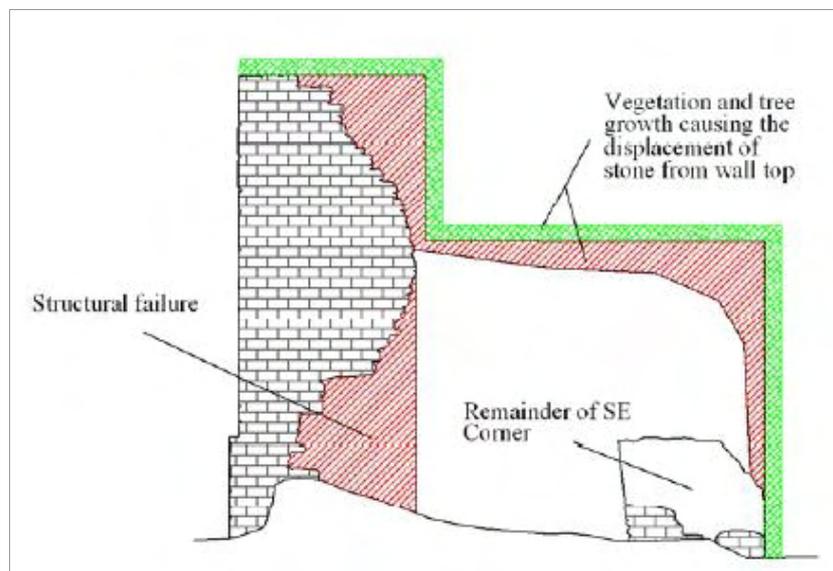
Fig. 26. Problem areas in the south wall

Urgent works are required to secure the loose and overhanging stones in danger of falling (Fig. 26). The removal of vegetation from the south east elevation and re-pointing and re-bedding of loose masonry is necessary.

- Securing of all loose and dislodged stones from the wall tops and inner chimney areas. The removal of some stones may be necessary to remove excessive vegetation. The trimmed back vegetation should be treated prior to the stones being re-bedded in lime mortar.
