Conservation Management Plan for the Blast Furnace Remains at Ballyvannan, Co. Clare

History, survey and structural assessment

November 2015

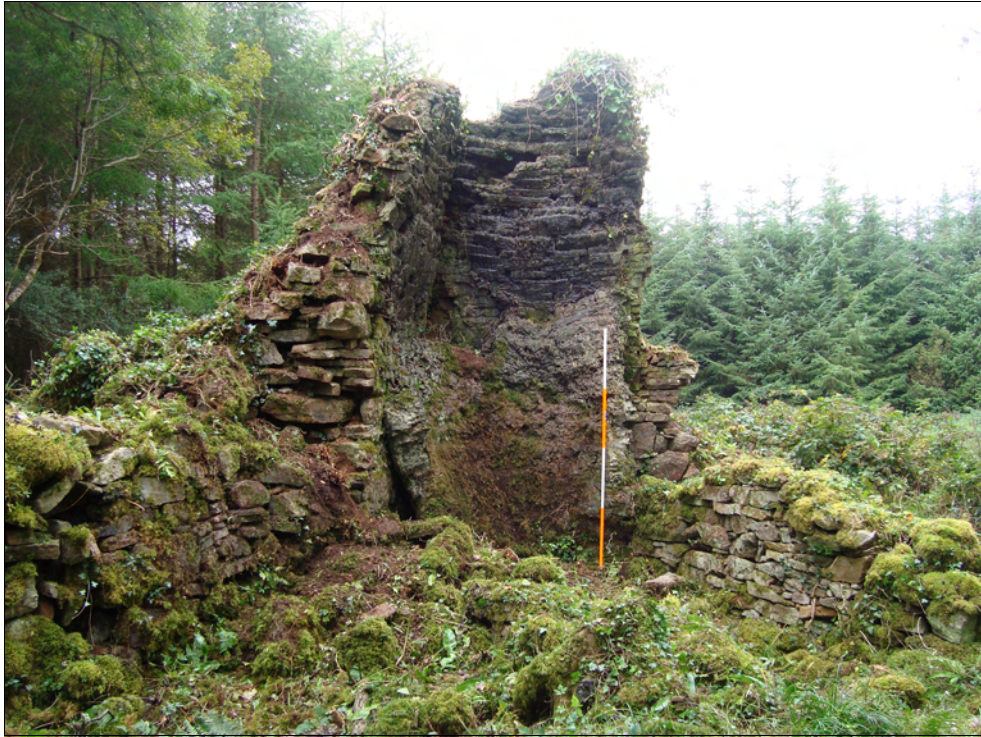
The south- and east-facing inner walls of the hearth area and chimney are preserved up to a visible height of 4.3m. Abutting the lower parts of the inner walls are the remains of the stone-built hearth lining which is covered and replaced by a thick layer of slag (Figs. 4 and 5). On the eastern side, at the base, a rectangular cavity is visible (Fig. 6). On the other, southern base, an irregular cavity is seen, possibly deformed by fire action (Fig. 7). The interior walls would have enclosed an area with a side length of approximately 1.3m. The inclining upper walls are heavily vitrified and have some unreduced pieces of iron ore adhering.

Fig. 4 Interior of Ballyvannan furnace from the south

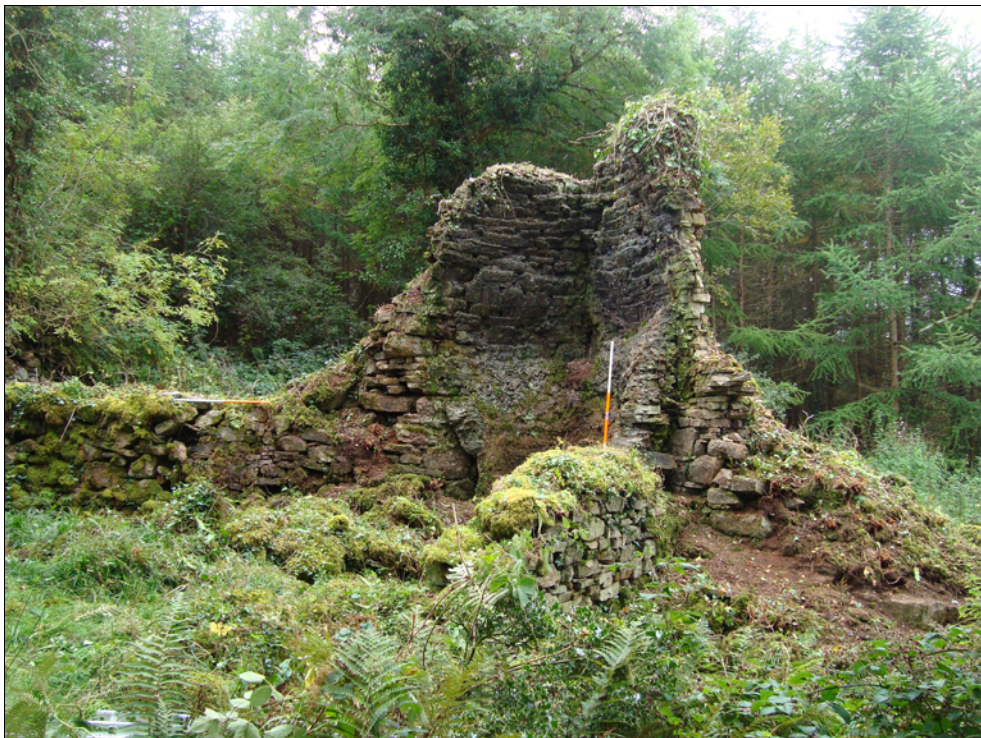
Fig. 5. Interior of Ballyvannan furnace from the east

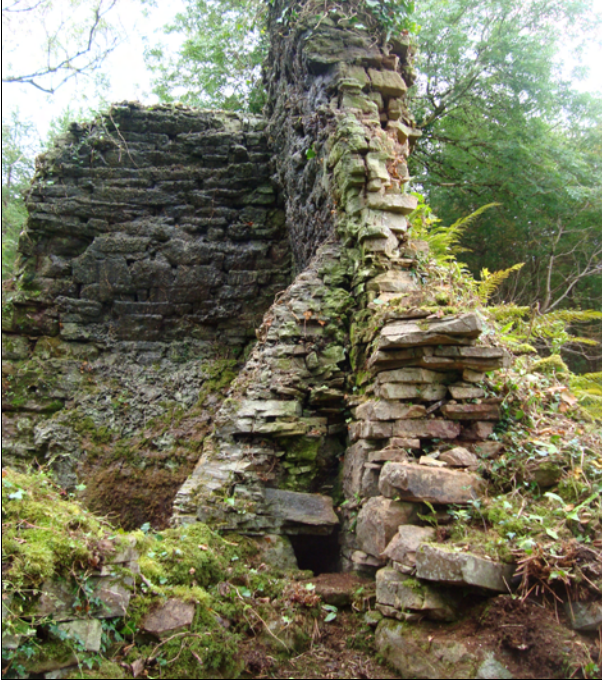
Fig. 6. Rectangular cavity in the northern hearth lining

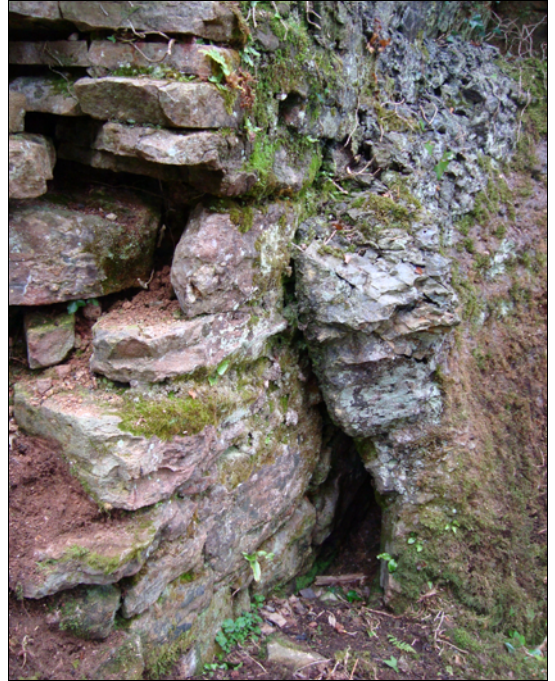
Fig. 7. Irregular cavity in the western hearth lining

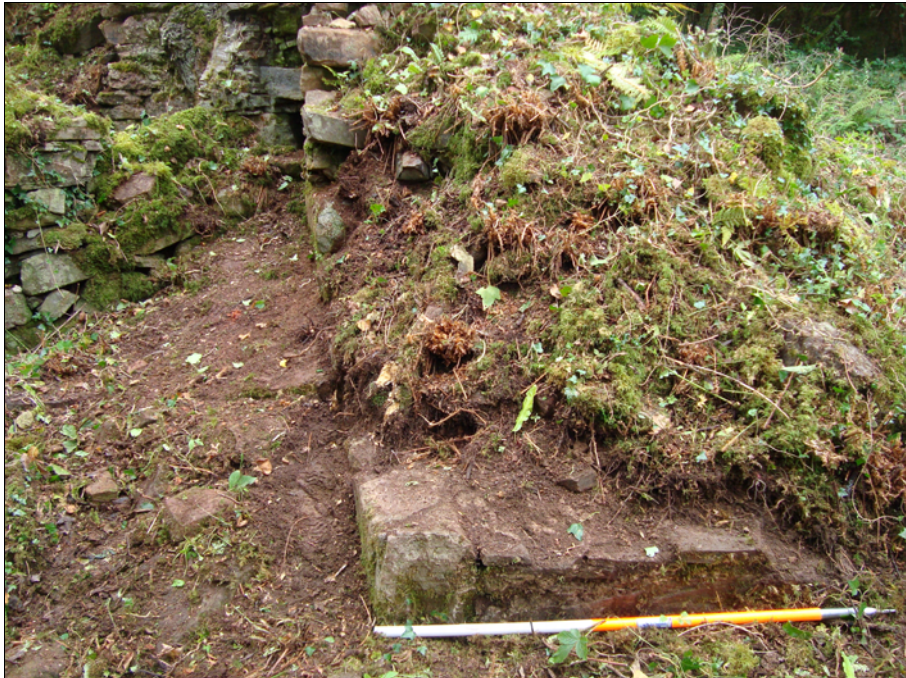
To the east of this, the upper courses of the side of one of the arches and small part of the outer furnace wall are visible (Fig. 8). The arch wall is about 2.5m long and is placed at an angle of about 60° to the outer wall.

Fig. 8. Arch wall and outer wall section from the east

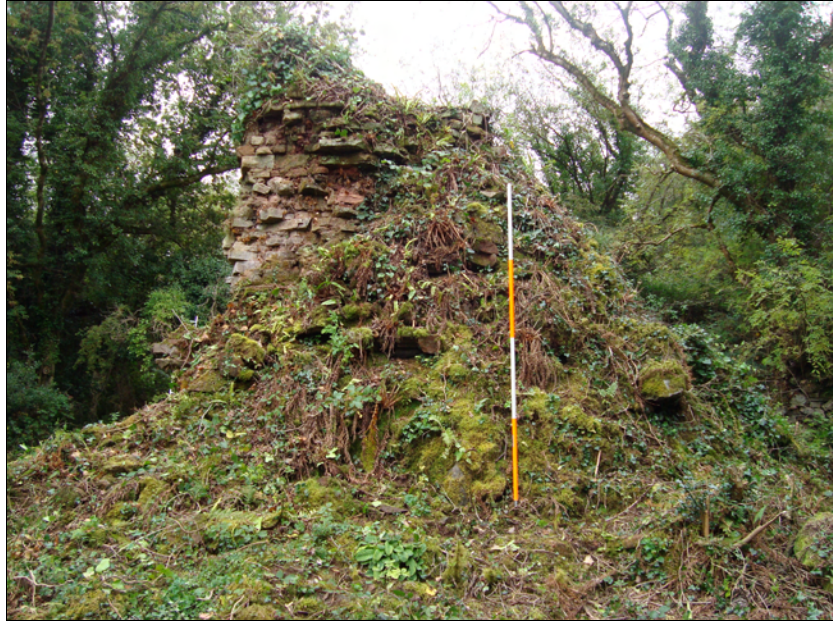
Apart from the section of outer wall mentioned above, the exterior of the furnace consists of poorly preserved masonry and accumulated wall collapse (Figs. 9 and 10).

Fig. 9. Furnace exterior from the north

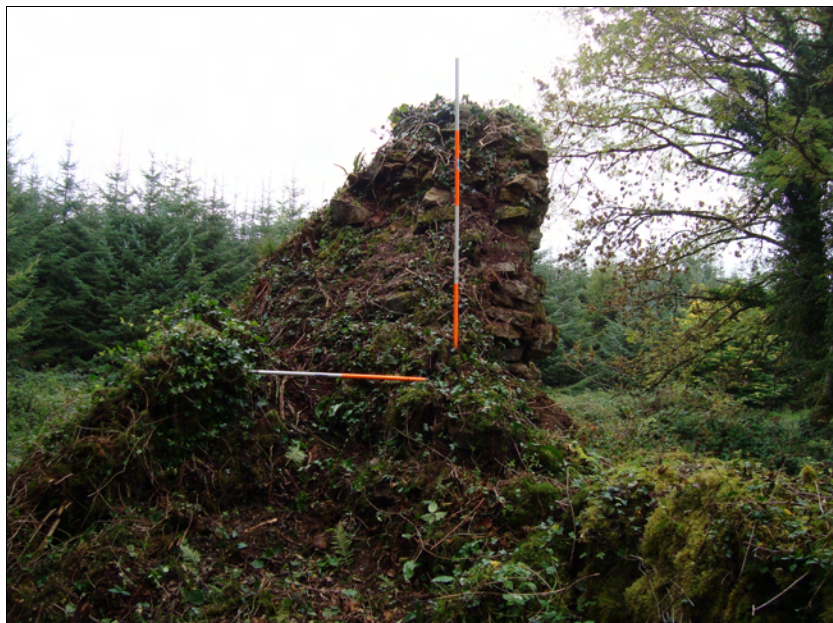
Fig. 10. Furnace exterior from the west

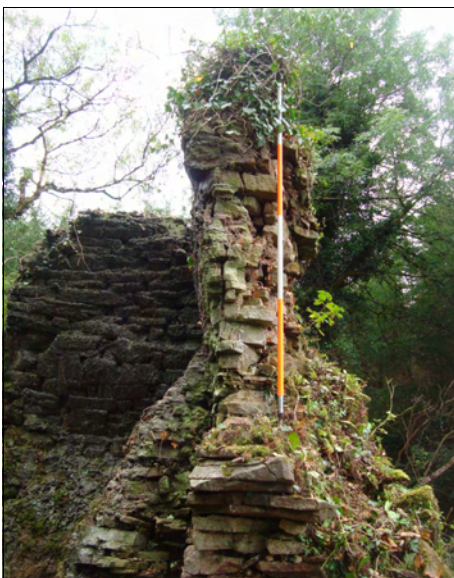
The furnace remains at Ballyvannan are in danger of further structural failure if certain repairs are not carried out in the near future. The North East and North West sections of the flue are in danger of collapsing (Fig. 10). Loose masonry along the top and sides of the remaining sections need to be re-pointed (Fig. 11). Vegetation along the top and sides need to be trimmed back and treated prior to any re-pointing works to prevent further damage caused by vegetation.

Fig. 10. Upper north east section

The consolidation of the remaining sides of the flue should protect against further collapse of the structure. It is not recommended to remove any of the slag or material build up from the north and south elevations as they may be providing structural support to the flue lining.

- Removal and treatment of vegetation on the wall top and sides of the remaining flue.
- Re-pointing and consolidation of the remaining top and sides of the flue lining.
- Further archaeological excavations are necessary around the base of the remaining structure. This is necessary to assess the structural stability of the remaining furnace elements and the design and footprint of the original furnace

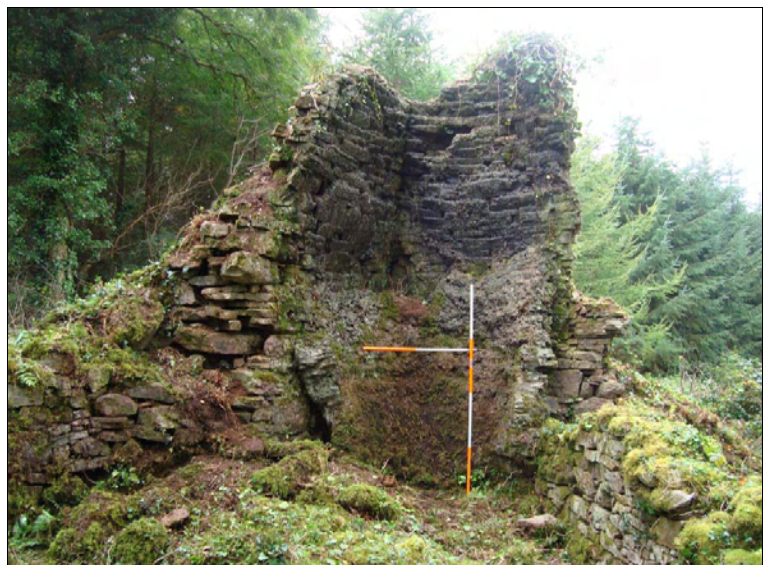
Fig. 11 Furnace interior showing poor masonry quality
