Conservation Management Plan for the Blast Furnace Remains at Bealkelly, Co. Clare

History, survey and structural assessment

November 2015

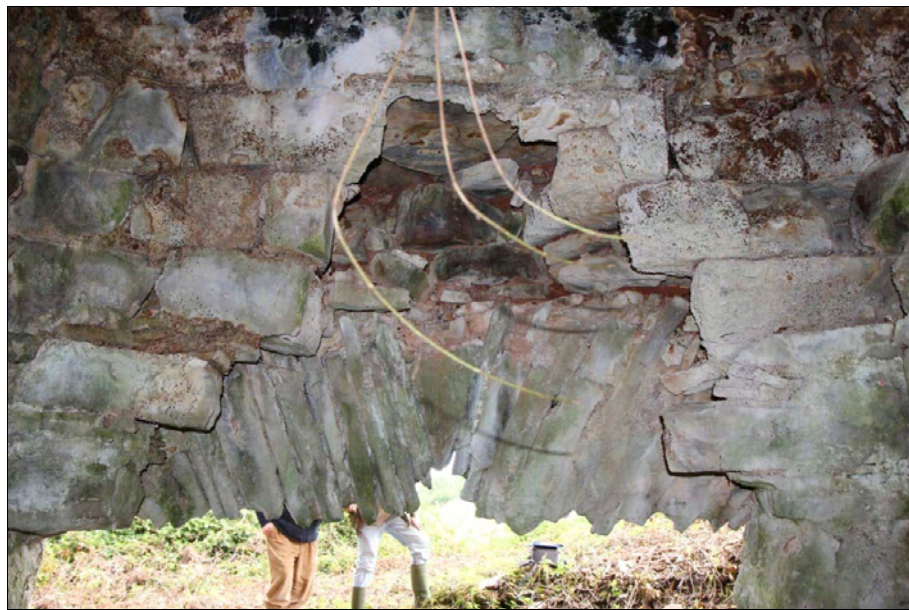
There is a large crack formed in the arch of the East elevation. The crack begins at the bottom of the arch and extends approx 1m above the top of the arch. The arch is also badly damaged on its rear elevation (Fig. 15). Stone has been robbed out of the back of the arch exposing the inner arch stones and wall infill. The recessed section features some loose stones in risk of falling. The top section is covered by vegetation.

Fig. 15. Damaged interior of the East arch

The crack in the arch should be monitored for further movement (Fig. 16). The rear of the arch should be repaired to match existing to prevent further collapse to the back of the arch. Any sections of loose or washed out masonry should be re-pointed with lime mortar to prevent further deterioration of the fabric. The recessed section should be re-pointed as necessary to prevent any loose stones from falling.

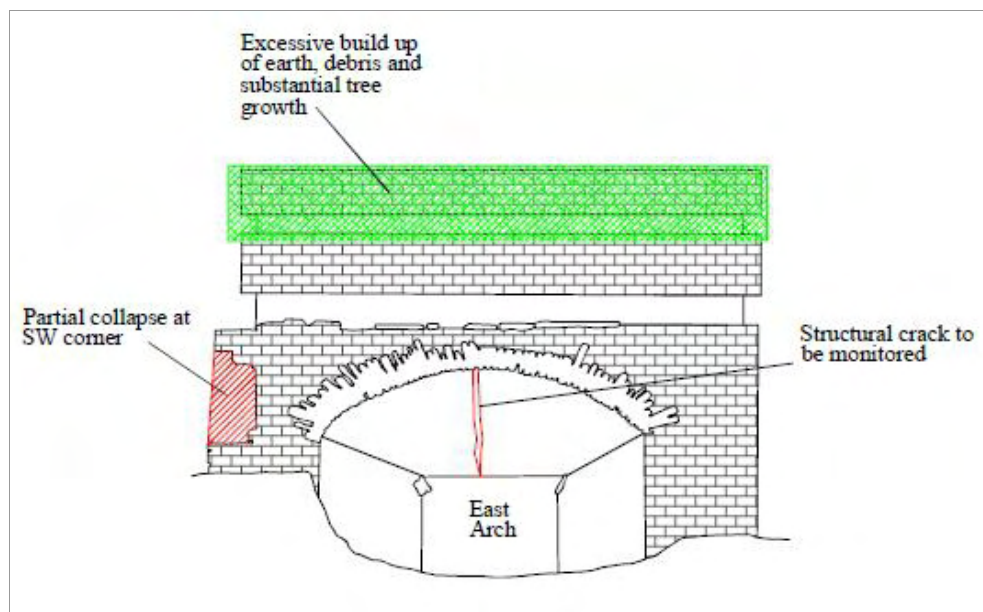
Fig. 16. Problem areas on the east wall

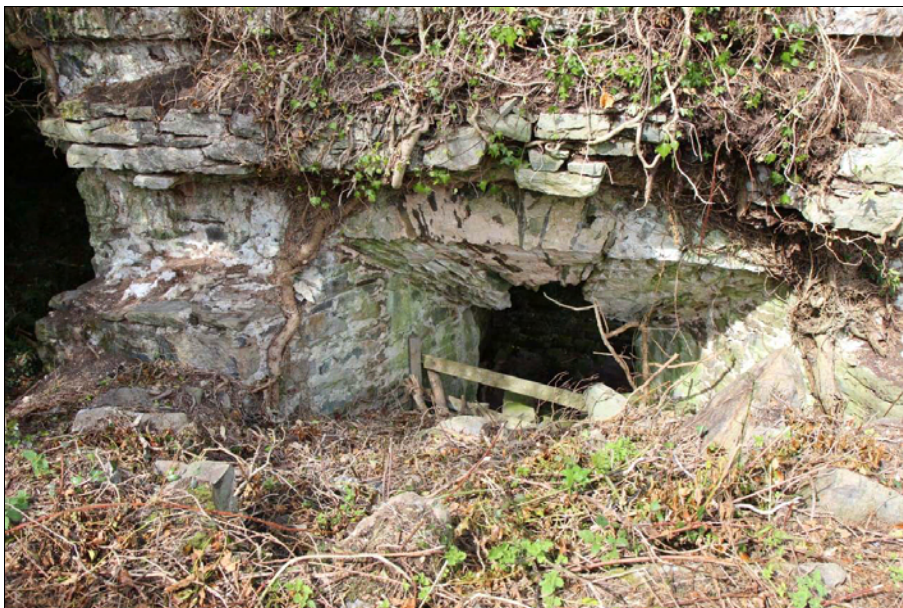
The South elevation is in a poor condition as there has been much damage done to the arch (Fig. 17). There is a significant build up of stone and debris against the base of the wall obstructing the arch. Significant ivy growth is causing the displacement of masonry directly over the arch. The recessed section above the arch is filled with debris and vegetation. The bottom of the arch is also damaged and missing some stone (Fig. 18). The top section of the South elevation is covered by vegetation and not visible.

Fig. 17. South Elevation Arch

Urgent works are required to consolidate the arch and masonry overhead (Fig. 19). Re-pointing in lime mortar should be carried out to help prevent further collapse of stone from over and beneath the arch. Replacing the missing structural timber should be considered as a long term solution to this major structural problem.

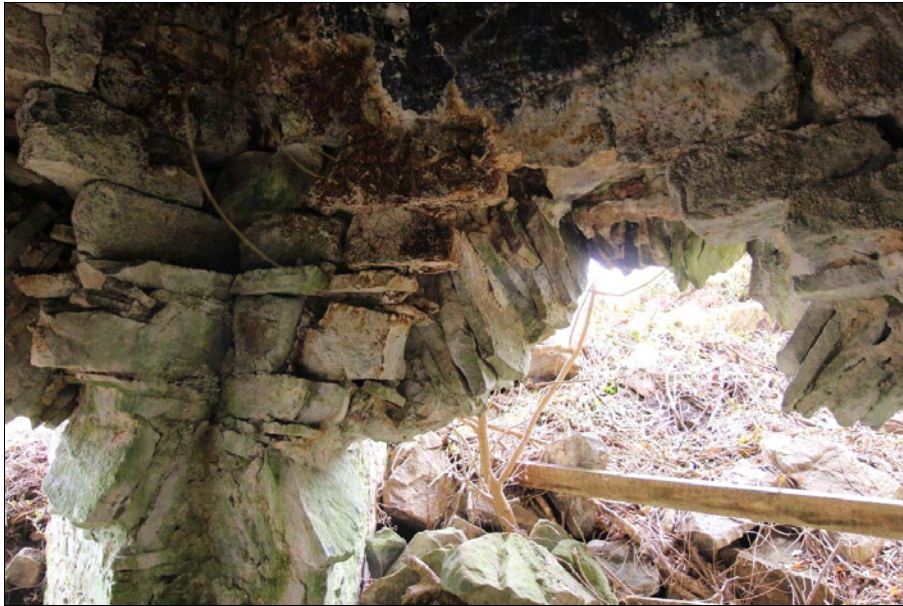
Fig. 18. Internal damage to South arch

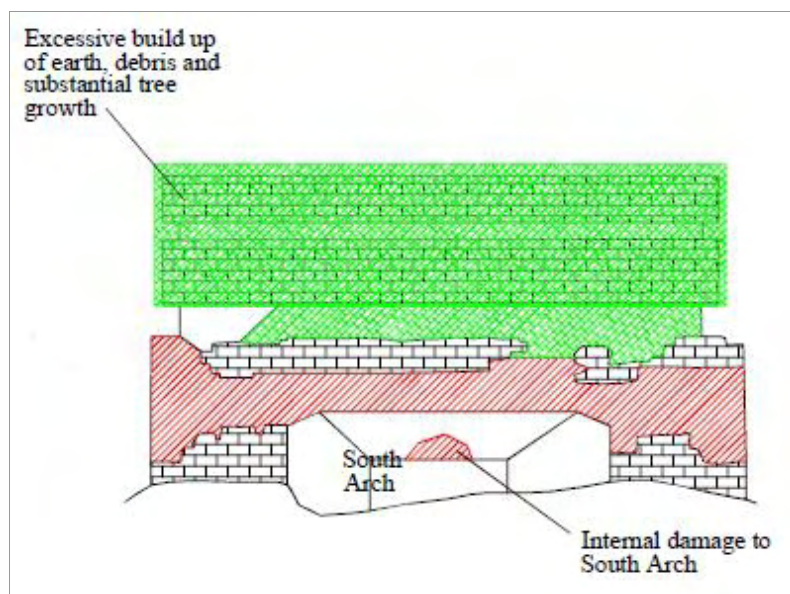
Fig. 19. Problem areas on the south wall

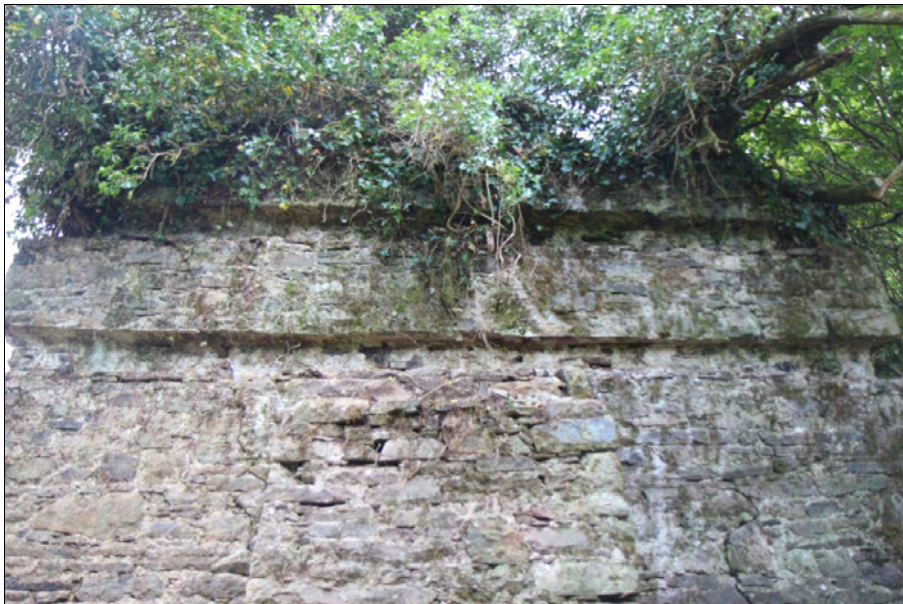
Fig. 20. North Elevation

The North elevation is in a reasonably good condition apart from the wall top where vegetation and

tree growth is displacing masonry which may be in danger of falling (Fig. 20). The North walls features a strong stone buttress. There are two minor cracks on the wall either side of the buttress which should be monitored.

Removal and treatment of the trees and vegetation from the furnace top to prevent further displacement of masonry (Fig. 21). After the trees and vegetation are removed any loose stones along the wall tops should be re-bedded in lime mortar. Crack monitors should be installed on both cracks to investigate any present movement and action taken if necessary.

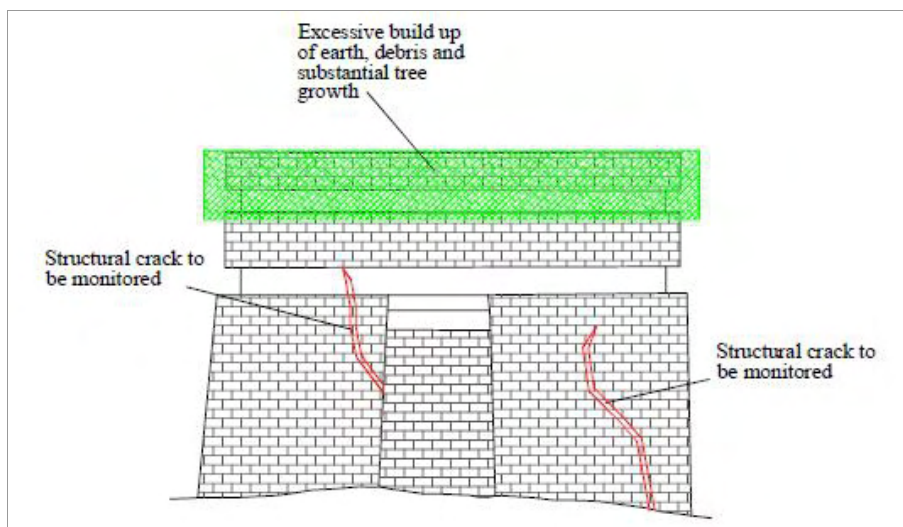
Fig. 21. Problem areas on the north wall

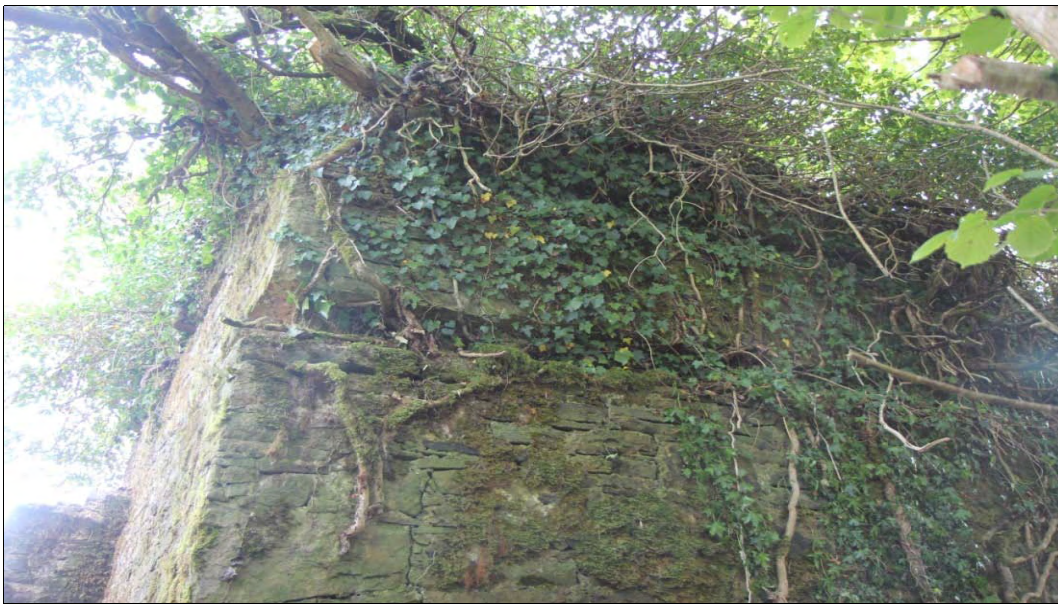
Fig. 22. West Elevation

The West elevation is in a generally good condition apart from the risk of falling stones from the wall top due to vegetation and tree growth (Fig. 22). There is extensive ivy growth on the top section of the wall.

Removal and treatment of vegetation and tree growth on the top section of the wall and wall top (Fig. 23). Localised re-pointing of washed out joints.

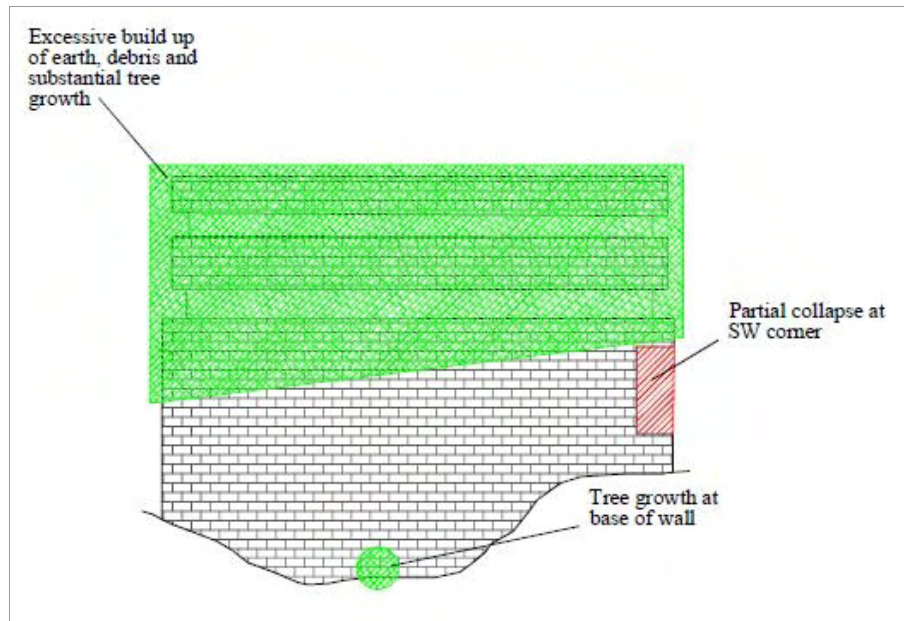
Fig. 23. Problem areas of the west wall

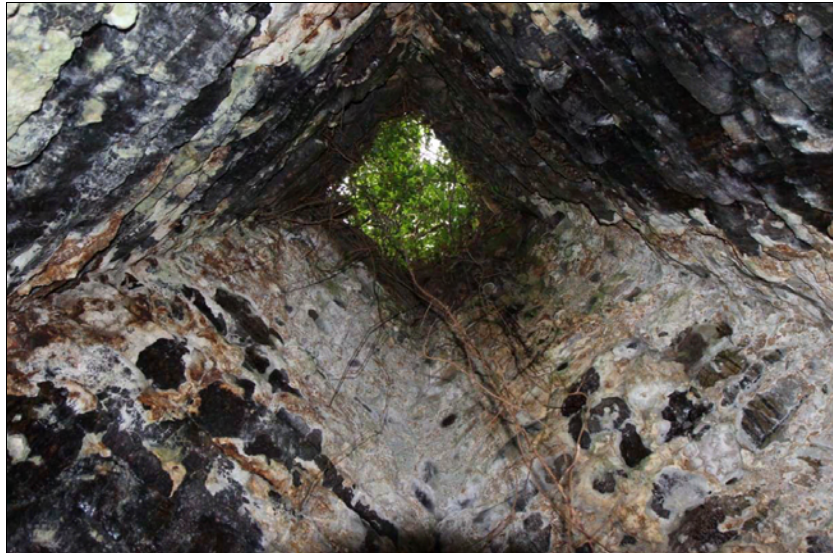
The interior of the furnace is in a fair condition with much of the original flue lining still existing (Fig. 24). There is much evidence of use in the form of soot and burned materials. The inside of the South and East arch are damaged.

Fig. 24. Inner chimney looking up

Removal and treatment of vegetation and tree growth on the top section of the chimney opening. Consolidation works should be carried out to the damaged arches to prevent further structural failure.
