Conservation Management Plan for the Blast Furnace Remains at Derryoover, Co. Galway

History, survey and structural assessment

November 2015

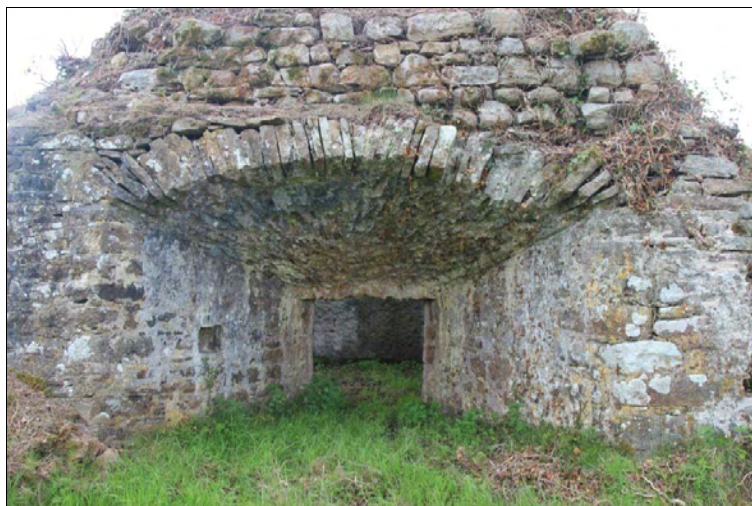
The North elevation appears to be structurally sound however there is a small amount of damage to the arch and some loose masonry on the wall top (Figs. 13 and 14). Vegetation is causing the displacement of stones on the upper section of the wall. The original lime render is still apparent underneath the arch and on the side walls.

Fig. 13. North wall showing damage to the arch

It is recommended that the arch on the North elevation is repaired to match existing with suitable stone and lime mortar. This will prevent further deterioration of the arch and prevent a future structural failure. The masonry on the upper section of the North elevation is in need of re-pointing and loose stones on the wall top should be re-bedded in lime mortar after the removal and treatment of vegetation growth on the furnace top.

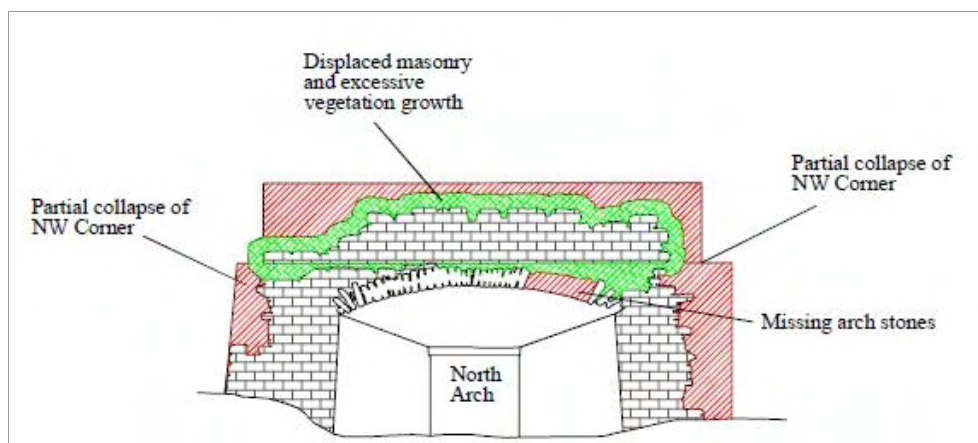
Fig. 14. Problem areas on the north wall

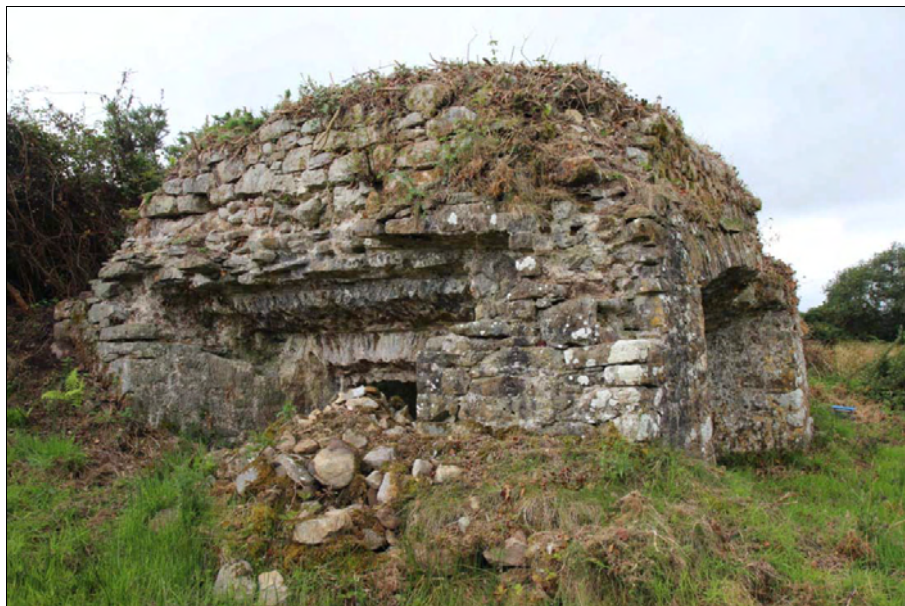
On inspection the East elevation appears structurally sound however there has been considerable damage caused to the arch (Figs. 15 and 16). The structural timber heads appear to have been removed leaving the stone exposed and overhanging above. There is loose masonry just above the arch and towards the top section of the wall being caused by vegetation growth. A small section of the NE corner has collapsed but does not pose any structural risks at this time. The stones above the arch are in danger of collapse due to their supporting timbers having been removed.

Fig. 15. East wall showing extent of damage to the arch

The removal and treatment of vegetation growth is necessary to prevent the further displacement of masonry on the upper section of the furnace. Consolidation works are required to the damaged arch to prevent further collapse of the overhanging stones. The upper section of the wall is in need of re-pointing to prevent further deterioration of the joints and mortar.

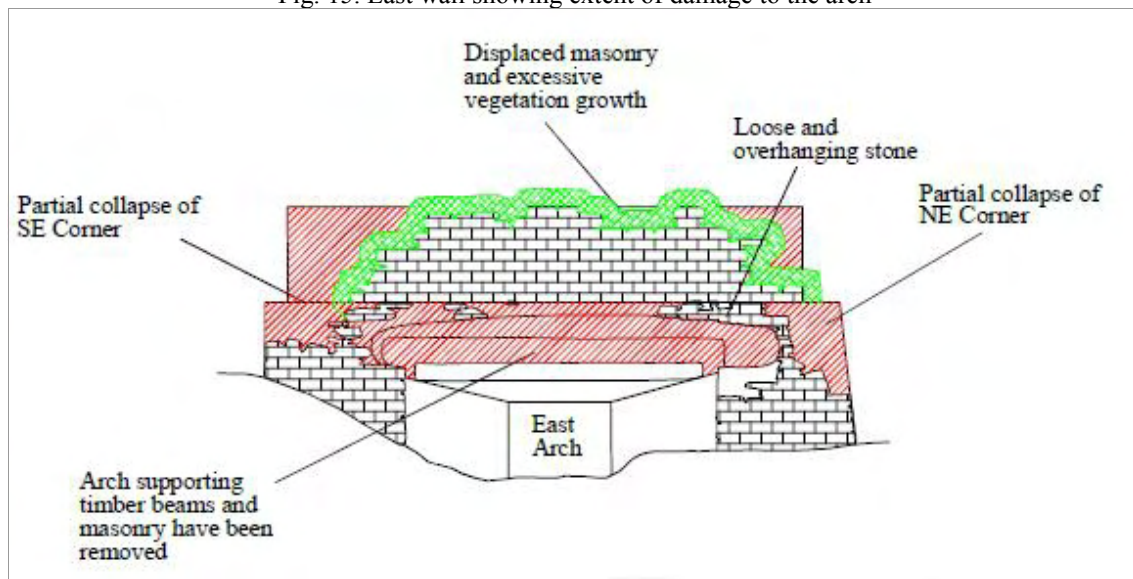
Fig. 16. Problem areas on the east wall

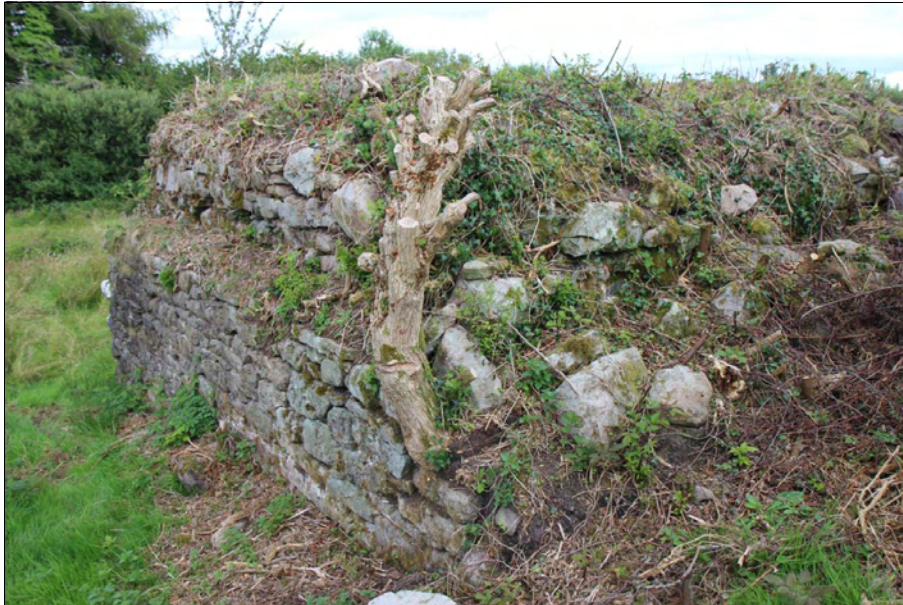
The South and West elevations are in a reasonably good condition structurally however there are still sections of loose masonry along the wall tops which may fall if not dealt with (Figs. 17 and 18). The west elevation is in need of re-pointing to prevent further deterioration and washing out of the joints. There is a small tree growing out from the SE corner which does not seem to be causing any major issues currently.

Fig. 17. Tree growing on the south east corner

Urgent works required on these sections of the furnace include the removal and treatment of vegetation growing on the top and mid sections to prevent the further displacement of masonry.

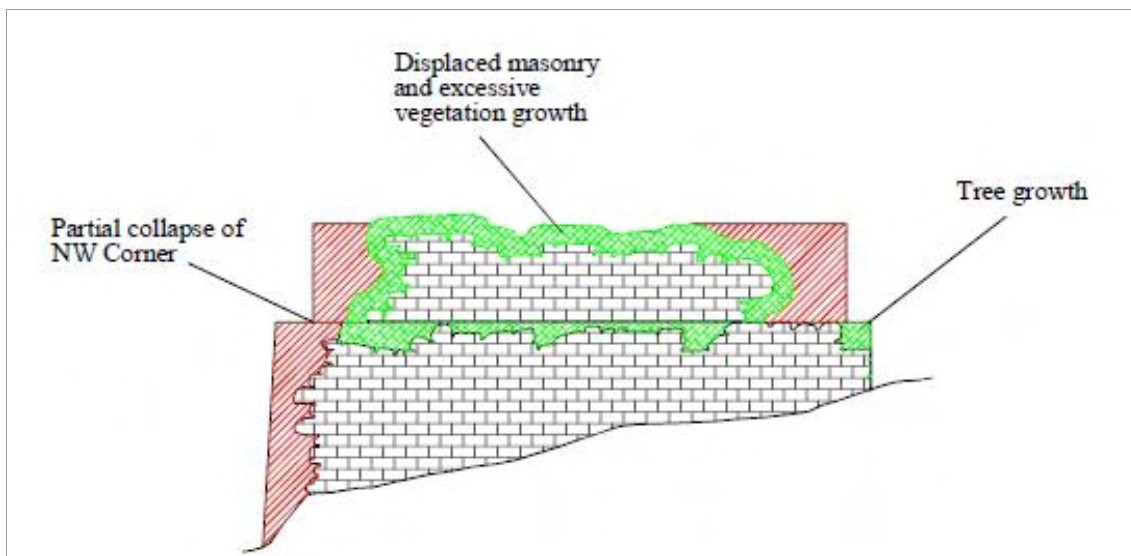
Fig. 18. Problem areas on the west wall
