Conservation Management Plan for the Blast Furnace Remains at Whitegate, Co. Clare

History, survey and structural assessment

November 2015

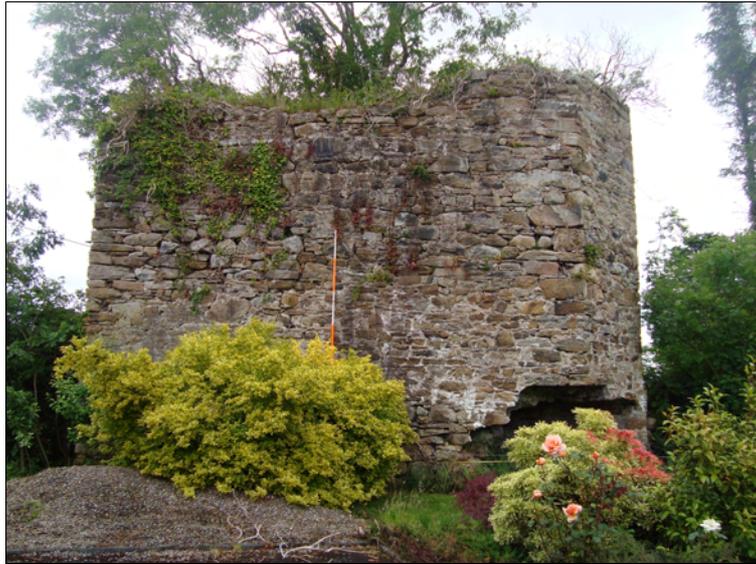
Fig. 4. West and south west walls of Whitegate furnace

The west wall is just over 7.8m long and 6.8m high (Fig. 4 and 5). It is a plain wall with the exception of a window on its lower northern side connecting to the passageway (Fig. 6). This window is 0.68m high and 0.32m on its exterior. The window is splayed towards the south and is 0.48m wide where it meets the passageway. This passageway exits in the chamfered south west wall (Fig. 7 and 8).

The West wall, on inspection, looks to be structurally sound however it does show signs of structural stresses and cracks (Figs. 19). There is a band of well pointed masonry approx. 1m from the ground and extending 2m above. The pointing of the stone below and over this area has been mostly washed out. The wall top is uneven and there is a lot of vegetation growing from it. There is some damage apparent to the opening of the passageway where stone has been robbed out from the open arch. A crack is visible in the centre of the West wall running from the top down approx. 4m.

The West wall is structurally sound however works are required to prevent any further deterioration of the wall namely the wall top, passageway arch and the crack in the centre (Fig. 20). Much of the wall is also in need of re-pointing to prevent further washing out of the joints.

- Clear out passageway of all debris and rubbish.
- Re-pointing in lime mortar of the West and East Facing walls to prevent further deterioration of the fabric.
- Re-pointing of the arch of the passageway at the SW corner of the structure to prevent any further collapse.

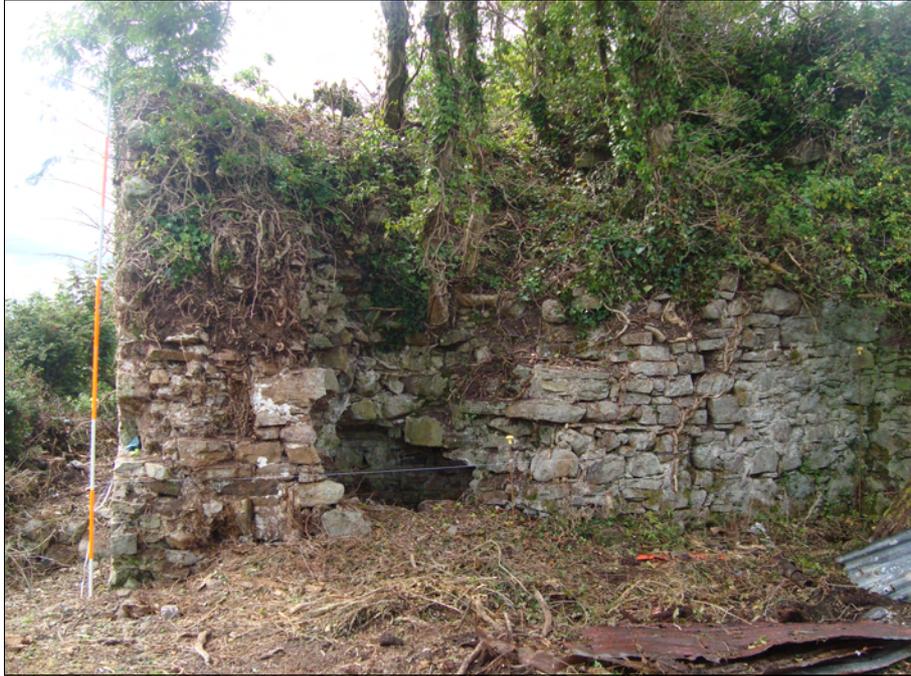
Fig. 9. North wall of Whitegate furnace

The north wall is 9.8m long and just under 6m high at its western corner (Fig. 9 and 10). A wall, seeming part of the original design, protrudes to the north in the western half of the northern wall. This wall is about 1.8m wide at its base but is stepped on both sides.

In the eastern half of the northern wall the stones are missing and replaced by rubble nearly to the ground level of the passageway behind it. As the ground level on the outside is substantially higher this appears to have been built up, while the missing stones appear to indicate that there was an additional doorway or window into the passageway at this point. The masonry structure at the eastern corner of this wall indicates that there was another wall, 1.1m wide, protruding north at this point.

The North elevation is very overgrown and has seen much structural collapse (Fig. 23 and 24). The north east corner stones are being dislodged by vegetation and are in risk of falling. The removal of vegetation from the rear of the West wall top is necessary also to assess any existing structural issues. The trees growing on the furnace top and off the North elevation need to be further assessed to investigate the amount of structural damage being done and the best treatment for each one. The breach into the passage way should be made good to prevent any further collapse.

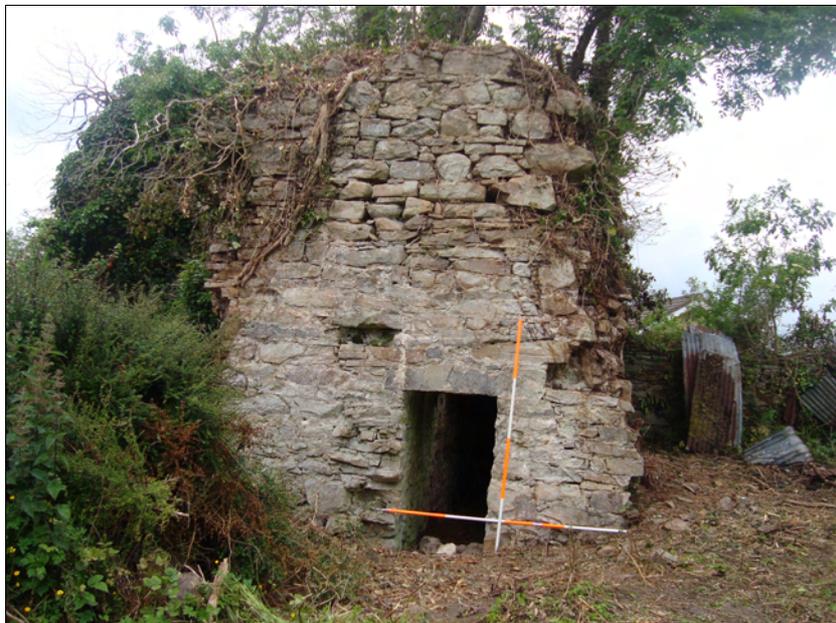
The best preserved part of the east wall is the part surrounding the passageway entrance which is currently 1.5m high and just over 0.8m wide (Fig. 11 and 14). At the southern end of this upstanding part the inner wall of one of the arches is preserved as well as several of the arch stones (Fig. 12). A recess between the doorway and the arch, above what appears to have been a wall protruding towards the east, could be related to a shelter built in front of the arch. At the southern corner of the eastern wall, the base of the pillar between the two arches is preserved. Several stones on the northern side of this pillar very likely represent the other inner wall of the same arch mentioned above (Fig. 13).

Fig. 11. East wall of Whitegate furnace with passageway entrance

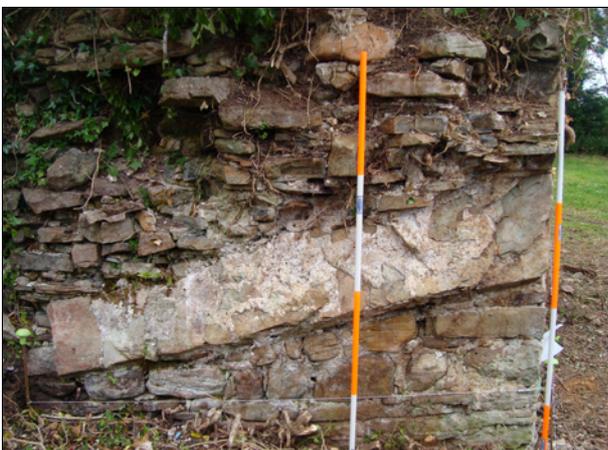
Fig. 12. North side of the arch in the east wall

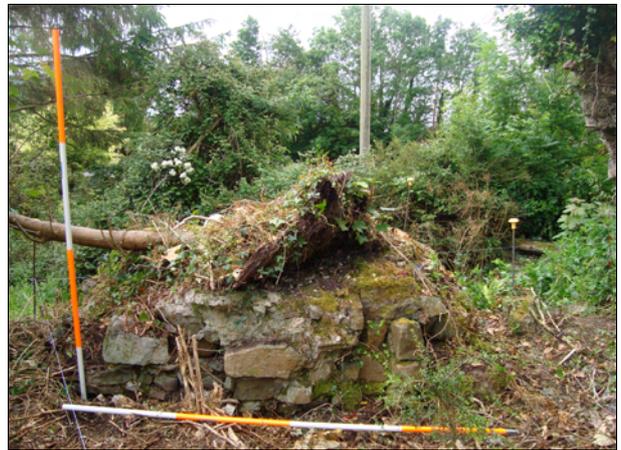
Fig. 13. South side of the arch in the east wall

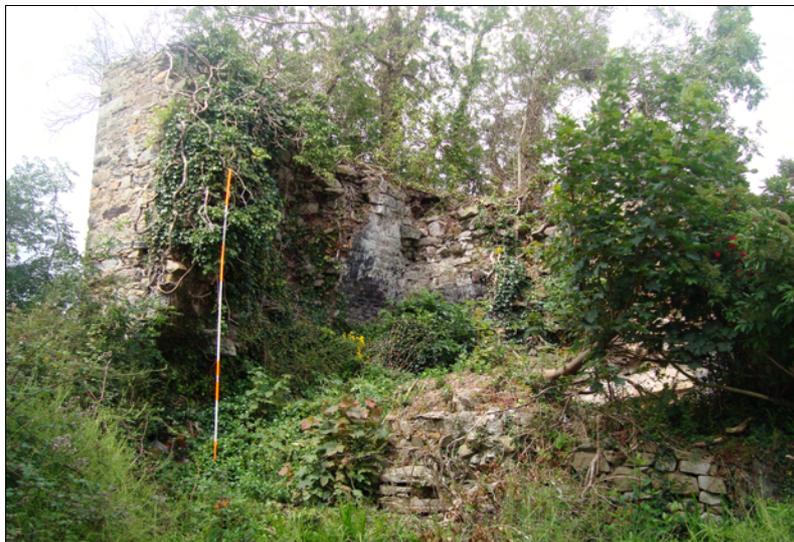
Fig. 15. South wall of Whitegate furnace

Most of the upstanding southern wall consists of of large overhanging wall section attached to the south west wall (Fig. 15 and 16). In the lower part of this wall section is a rectangular recess above a badly preserved wall protruding to the south (Fig. 17). The recess is about 0.25m wide, 0.2m high and 0.25m deep and its function unknown. The same pillar described above has the remains of a third inner arch at the western end of its south facing face (Fig. 18). The lower part of the hearth area is taken up by a large tree trunk but two internal faces of the higher chimney are visible.

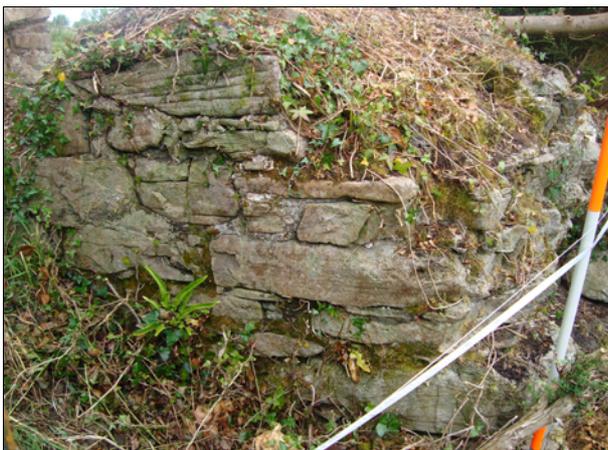
Fig. 17. West side of the arch in the south wall

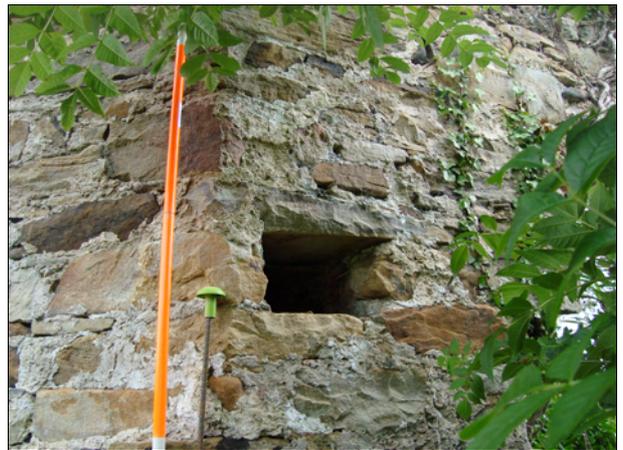
Fig. 18. Recess in the south wall
