Conservation Management Plan for the Blast Furnace Remains at Bealkelly, Co. Clare

History, survey and structural assessment

November 2015

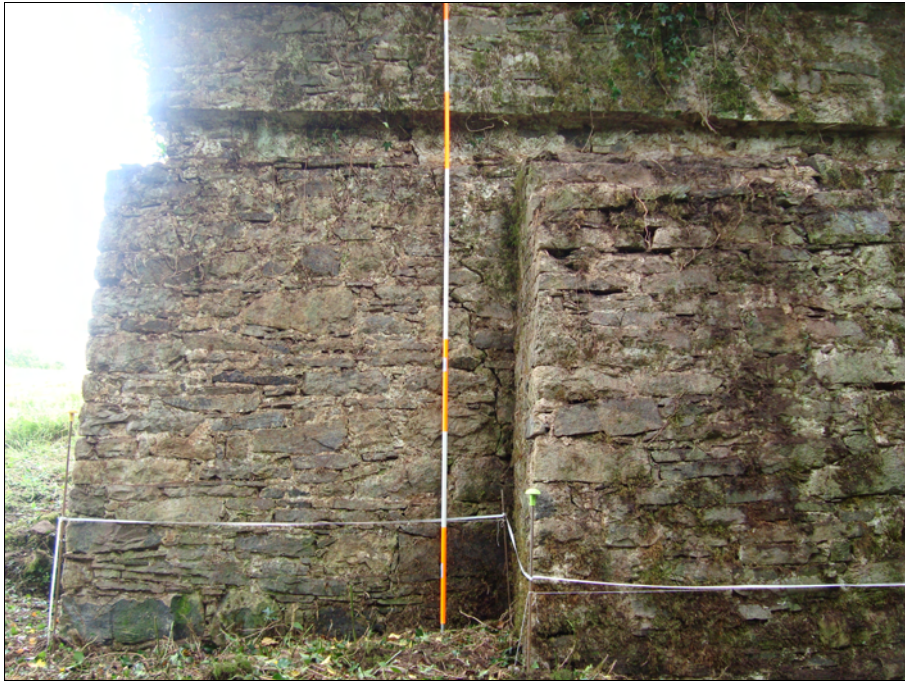
Fig. 10. East side of the north wall

The north wall was seemingly originally a plain masonry structure but at a later date a buttress was built against it (Figs. 10 and 12). This buttress is over 2.9m high, 1.3m wide and just under 1m deep at its base. It has a reclining front face and near its top is stepped twice (Fig. 11).
