Conservation Management Plan for the Blast Furnace Remains at Derryoover, Co. Galway

History, survey and structural assessment

November 2015

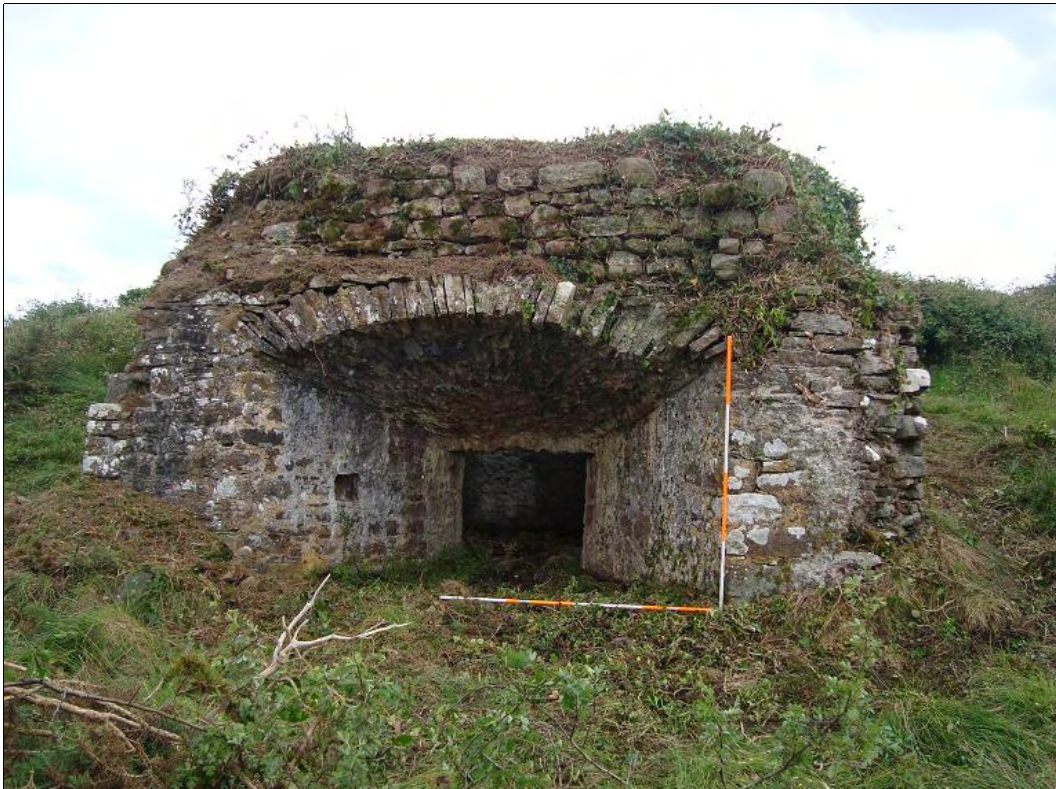
Fig. 5. North wall of Derryoover furnace

Most of the north wall is taken up by the tapping arch where both the liquid iron and the waste material (slag) would have been removed from the hearth (Figs. 5 and 6). This arch is 3.8m wide and about 2m high at its front and end as a square opening of about 1.2m where it meets the hearth area. About midway the east wall of the tapping arch, there is a rectangular recess with side lengths 0.3m and 0.2m and depth 0.2m, the function of which is function is unclear (Fig. 7).¹⁶ The top of the western tapping arch wall has imprints of timber or wattle, part of the construction frame for the arch (Fig. 8).

The full north west corner is missing its stones and it is possible that there was a wall built into the furnace at this point. The stones above about 1.5m are also missing on the north east corner and this might also represent a robbed out wall, but then with a doorway.

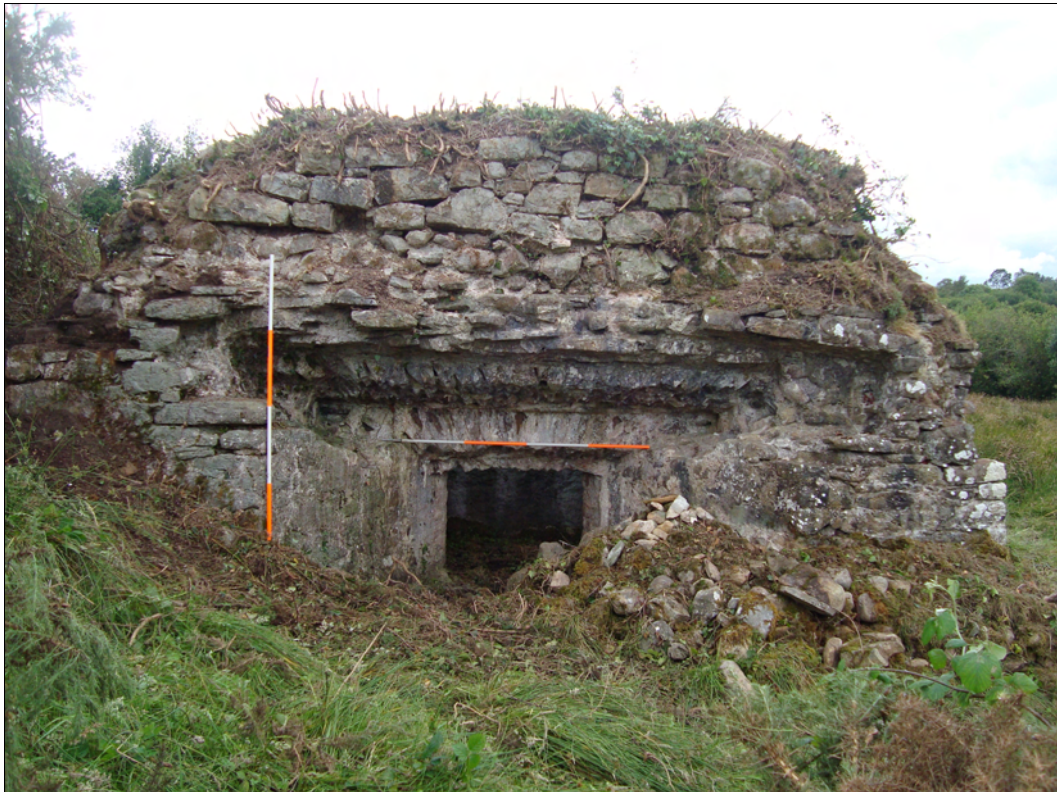
Fig. 9. East wall of Derryoover furnace

The east wall is the setting for the blowing arch where the water-powered bellows would have been situated (Figs. 9 and 10). Across the the top of the arch are the recesses of three horizontal beams which would have supported the bellows. The outer recess is the largest, measuring 4.8m by 0.7m by 0.5m. The middle beam would have measured about 4.0m by 0.35m by 0.35m and the innermost one around 3.45m by 0.25 by 0.25m. The arch in this wall is nearly 3.7m wide and about 2m high at its front and also ends a square opening of 1.2m side length.

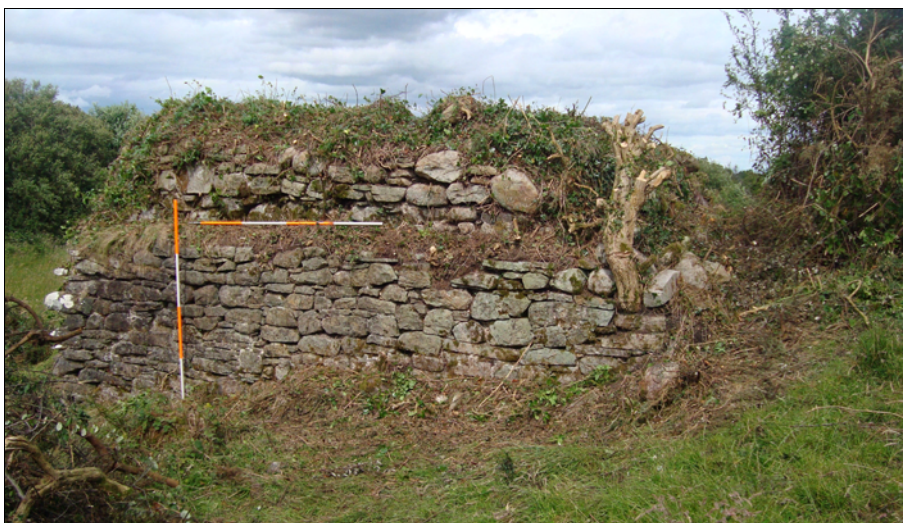
Fig. 11. West wall of Derryoover furnace

The west wall is a plain wall without distinctive features while most of the south wall is buried by material built up between it and the slope of the hill (Figs. 11 and 12).
